## Lapindo Embankment Security Monitoring System Based on IoT

Shazana Dhiya Ayuni<sup>1</sup>, Syamsudduha Syahririni<sup>2</sup>, Jamaaluddin<sup>3</sup>

### ABSTRACT

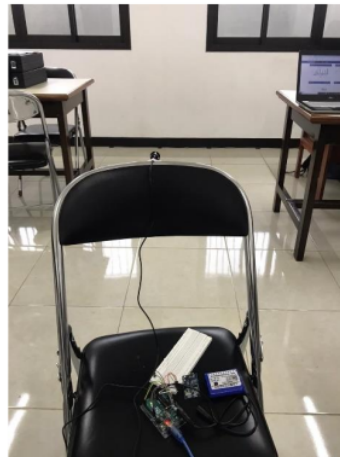
Figure 3. Calibration Ultrasonic sensor

We conducted the experiment in the electrical lab, placing sensors on the chair, and measuring the distance by moving the chair 50cm at the real distance. The sensor then uses Thing Speak to deliver distance data to IoT application through the web and smartphone. The ultrasonic sensor will generate an error rate by comparing the actual distance with the distance in the application. The measurements are 50 centimeters, 100 centimeters, 150 centimeters, 200 centimeters, 250 centimeters, 300 centimeters, 350 centimeters, 400 centimeters, 450 centimeters, and 500 centimeters.

The average error rate in Table 1 is 1.94 percent, which can be influenced by uneven and flat surfaces in the lab room, such as walls and windows on the right and left sides, which cause the ultrasonic sensor to pick up waves reflected from the wall. In contrast to actual distance. However, as the distance between the two points increases, the error rate decreases. According to the datasheet for the DC 5 V distance waterproof sensor ultrasonic module, which may be used indoors or outdoors, the greatest distance this ultrasonic sensor can capture is 5 m or 500 cm.

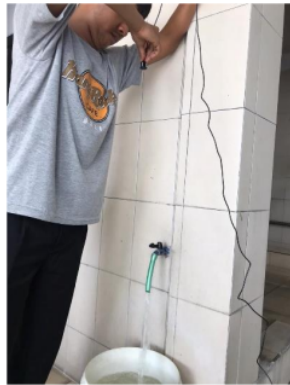
Figure 4. ultrasonic sensor testing in a water tank

The ultrasonic sensor works properly after calibration. The ultrasonic sensor will then be directly tested against the water overflow. The test was conducted at UMSIDA campus 2, namely in the bathroom, by slowly filling the bath with water and monitoring the change in the output value produced by the ultrasonic sensor as shown in the Blynk application. This can be seen in Figure 5 as follows.

Firstly, the water tank is emptied, then the water tap is turned on to simulate the embankment overflowing with mud. The goal of this test is to see if the ultrasonic sensor can detect water overflow, and if so, the Blynk program can

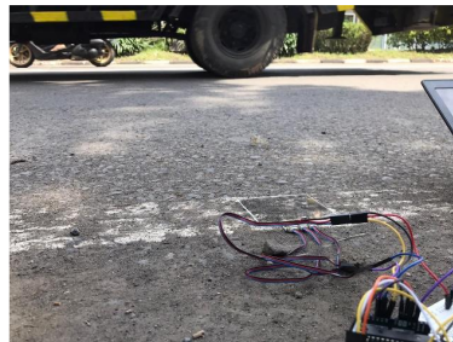
Figure 9. Accelerometer Sensor Testing on the Highway

The next accelerometer sensor test will take place on the road. The purpose of this experiment is to determine the vibration characteristics of vehicle passing. When several heavy vehicles pass, the embankment to repair the damaged embankment construction.

The test was carried out for two hours and conducted in front of UMSIDA campus 2.

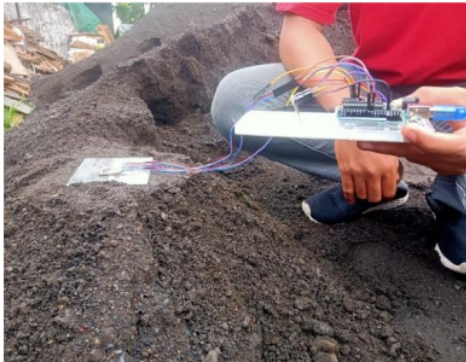
Figure 13. Normal Condition of Accelerometer Sensor on Artificial Dike

In addition to abnormal conditions, a normal condition test is also carried out on the accelerometer sensor on the artificial embankment. In order to know the values for each axis when nothing happens to the artificial embankment.

Figure 13 shows the condition of the accelerometer sensor before the artificial embankment was deliberately removed to determine the normal value of the sensor.

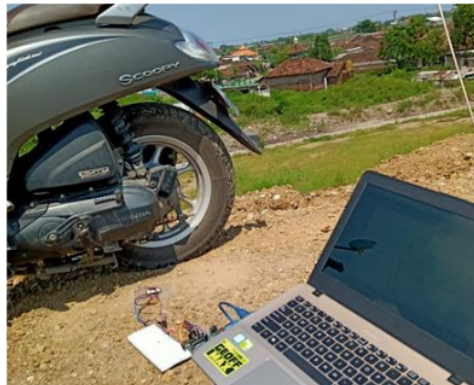
Figure 14. Accelerometer Testing at the Lapindo Embankment

When Lapindo is covered, the following test will be performed. It's the same as in the artificial embankment, but we were examining to see if the vibration and the resulting graph are similar so that the reference value is same. The first is that the sensor receives vibrations in the form of footsteps and passing motor vehicles, as shown on Figure 14, which is used to distinguish between normal and abnormal embankment conditions. The result is then displayed in

MATLAB as a graph, where it can be seen that the characteristics of the graph when a car passes by and the footsteps are remarkably similar. But it is not too dissimilar from the previous test on artificial embankment.
